Manhole Inspection Summary

Manhole # S33AA2005MH

Insp Date: **4/18/07 10:45 AM**

Location Address: **5417 SPRINGLAKE WAY**

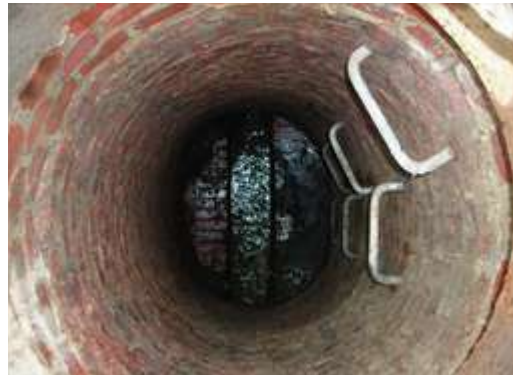
Top View

Evidence of surcharge - Bench debris.

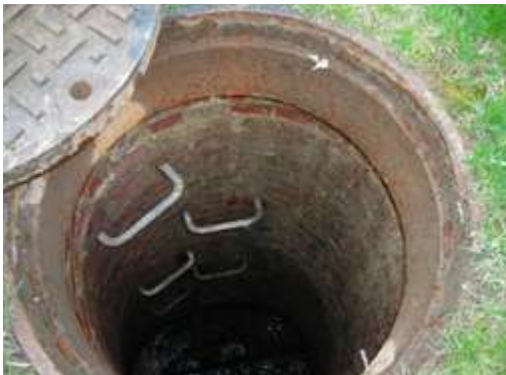
Defect

Frame leaks. Adjustment, Corbel and Barrel infiltration - other side.

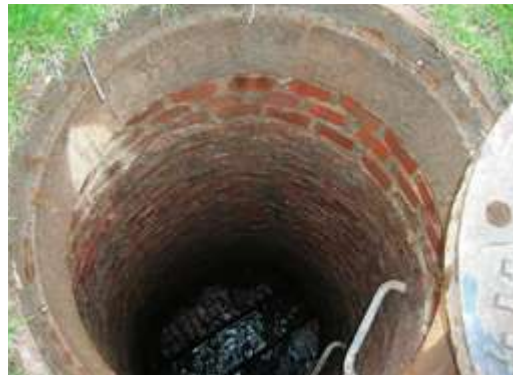
Defect

Frame leaks. Adjustment, Corbel and Barrel infiltration.

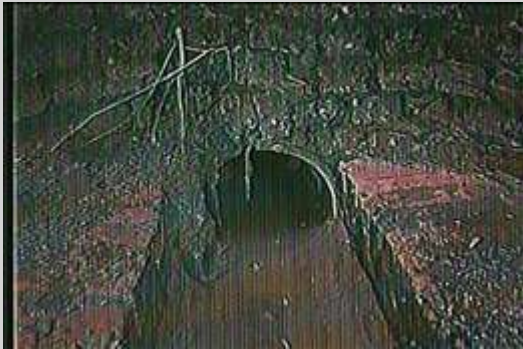
10 in. Circular Gravity Sewer Pipe Out @ 12 O'Clock

Barrel deterioration, root intrusion and infiltration. Channel deterioration.

Infiltration: **Evidence** Pipe Seal Cond: **Roots**

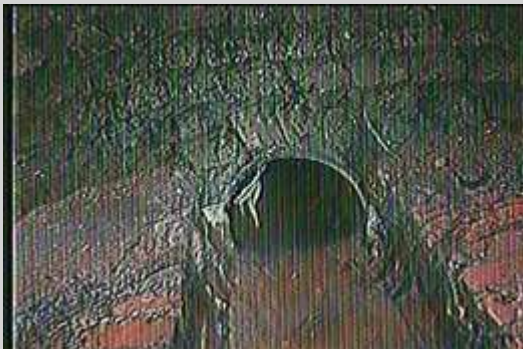
10 in. Circular Gravity Sewer Pipe In @ 6 O'Clock

Barrel deterioration, root intrusion and infiltration. Channel deterioration.

Infiltration: **Evidence** Pipe Seal Cond: **Roots**
